Manhole Inspection Summary

Manhole # S41KK_005MH

Insp Date: **1/23/08 9:56 AM**

Location Address: **1822 AIKEN ST**

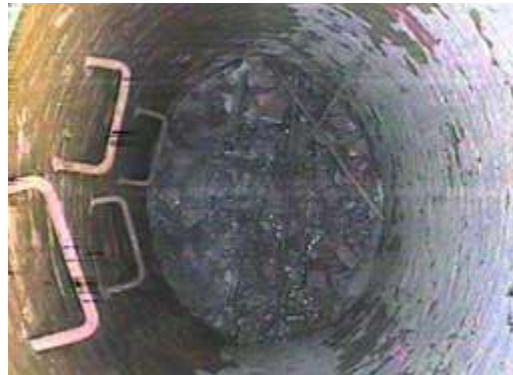
Top View

STORM COVER

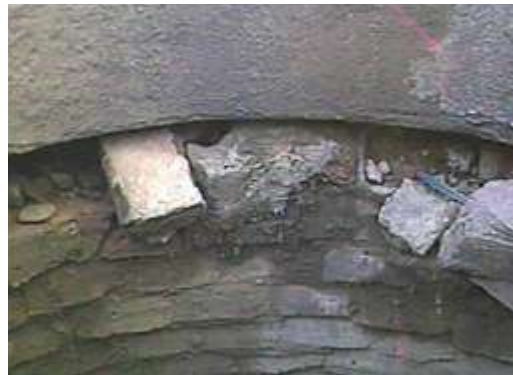
Defect 1

Condition: ☐ Sound ☐ Cracked ☐ Root Intrusion ☒ **Loose Brick** ☐ Deteriorated

CHIMNEY LOOSE BRICKS

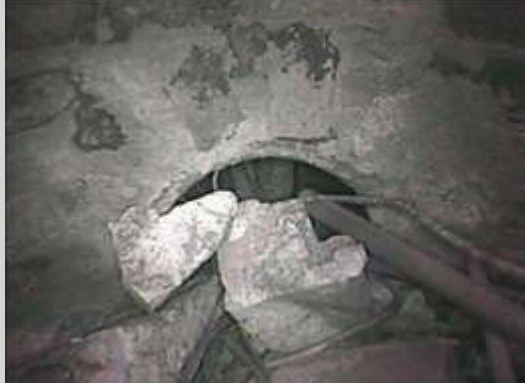
12 O'Clock Outflow

8 in. Circular Gravity Sewer
Pipe Out @ 12 O'Clock

Deposits: ☐ None ☐ Mud ☐ Sludge ☒ **Debris** ☐ Grease

Silt Depth: **7** (in.) Deposits Extent: **Heavy**
